# El Brocal Overland Conveyor: Control System Re-design and Implementation

**Bradley Lawson**

*Conveyor Dynamics Inc.*

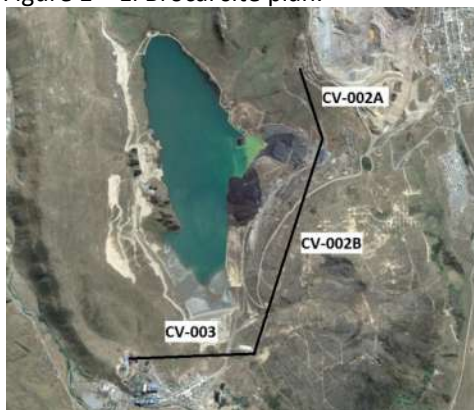
Figure 1 – El Brocal site plan.

The El Brocal overland conveyor system comprises of a series of three (3) straight conveyor flights designated CV-002A, CV-002B and CV003 to transport primary crushed mineral ore at a design capacity of 1,500 t/hr to achieve 18 kt/d (Figure 1)

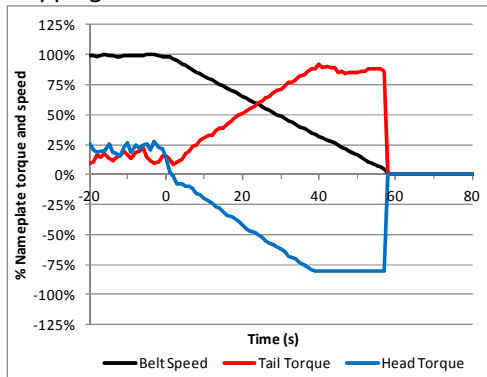
Analysis of the original PLC trend data obtained indicated that there were problems with the starting and stopping control strategy of the original conveyors. On conveyor CV-002B the drive torques between the head and tail were mirroring and opposing each other during starting and stopping which indicates that the drives are not following the same speed ramp or starting the speed ramp at the same time (Figure 8).

Figure 8 – CV-002B Starting and stopping motor torques – Original operation. Head and tail drives were mirroring and opposing each other.

Examination of the VFD ramp setting indicated the drives were utilizing the same speed ramp therefore the problem was attributed to the drives not starting the ramps at the same time. This effectively results in some of the drives trying to accelerate the conveyor whilst the other drives are trying to decelerate the conveyor in order to follow the defined speed ramp set point. During a long start or stop ramp sequence this ultimately results in drive torques increasing or decreasing progressively to their torque limits can also results in excessive belt tensions as drives oppose each other rather than working in unison.

The poor drive synchronization during starting and stopping was therefore due to poor communication network performance where the start and stop signals from the plant PLC were being delayed and received by the head and tail drives at different times. An investigation of the original communication network revealed that all drives, remote I/O and peer systems were operating on the same LAN network connection. The original communication system was simulated using Rockwell Integrated Architecture Builder (IAB) which revealed that the network was operating at 184% utilization and therefore was confirmed as the root cause of the drive synchronization issues.

CDI proposed to change the original communication network configuration by redistributing the network load over two separate peer and remote I/O networks as well as replacing the original CompactLogix to a higher capacity ControlLogix PLC in order to eliminate the drive synchronization issues.

In addition, all speed ramp generation was removed from the drives in order to be performed within the plant PLC. Whilst the reconfiguration of the communication network should effectively mitigate the synchronization issues alone, there is an additional advantage of performing all speed ramp generation within the plant PLC. By continuously broadcasting the speed set point update for all of the drives during the speed ramp sequence, any effect of a delay in a drives receiving the speed reference is minimized as the drives will receive the correct value typically within the following seconds and recover.

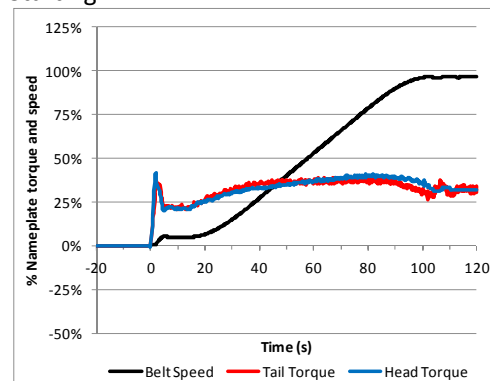
Following the onsite modifications and re-commissioning of the communication system and conveyor control system the PLC trend data was analyzed to verify the starting and stopping issues have been resolved. Conveyor CV-002B now starts and stops smoothly with the head a tail drives working together in unison (Figure 10).

Figure 10 – CV-002B Starting and stopping motor torques – After control changes. Head and tail drives are working in unison with similar torque levels.

On conveyor CV-002B, the change to performing the ramp generation with the PLC also enabled CDI to modify the starting ramp to incorporate a 20 second dwell period at 5% speed followed by a 80 second S curve ramp with an extended linear section. As noted previously, the dwell period effectively redistributes

unbalanced tension distributions within the belt from the prior stopping event prior to accelerating along the starting ramp. An extended linear section of the S curve was also utilized in order to reduce peak starting tensions in the conveyor as it was identified that the conveyor has marginal installed power available for starting under adverse inclines loaded conditions at the full design capacity.

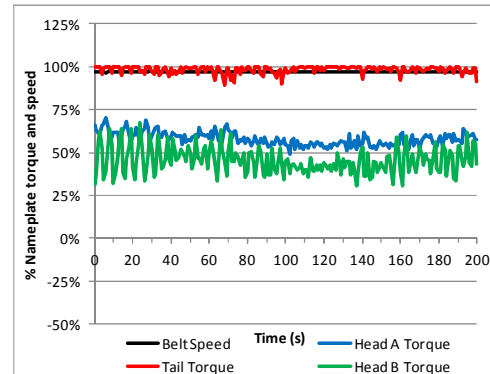
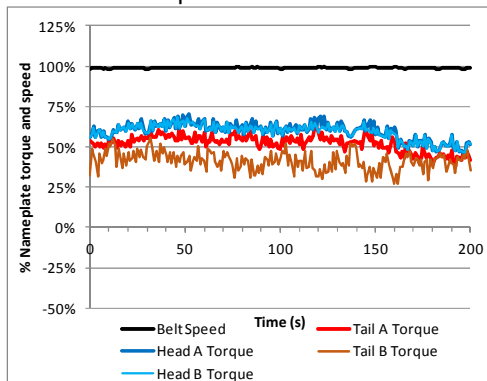
This load sharing strategy is problematic in general, due to the dynamic response of the conveyor as individual drive torque output levels change and the response time for this change to be felt by the other drives. As an example, the conveyor total torque demand level increases as the conveyor is progressively loaded, the master drive will absorb more torque in order to maintain the conveyor speed. The increase in master torque level is sent by the PLC as a new torque set point to the other conveyor drives which then also increase their torque output. However, the total torque output is now too high and is sensed by the master drive some many seconds later (depending upon conveyor length) and therefore decreases its torque and the cycle repeats (Cornet, 2002). This oscillation in torque levels can become unstable and practically cannot be eliminated through the use of control based proportional, integral and derivative control loop methods due to the complex and elastic nature of the mechanical conveyor system.

problems with the drive load sharing control strategy of the original conveyors once the conveyors were operating at speed. On conveyor CV-002B the drive torque levels between the head and tail drives were not only unbalanced but the drive torques between drives A and B on the same pulley shaft were also unbalanced and oscillating (Figure 12).

Figure 12 - CV-002B Running motor torques – Original operation. All head and tail drives were unbalanced and operating at different torque levels.

In order to achieve correct load sharing between drives on conveyor CV-002B, CDI proposed to assign Tail Drive A as the true master drive of the conveyor with Tail Drive B configured as a direct torque slave to drive A (Method 1). The tail drives were assigned as the true master drives due to the regenerative potential of the conveyor in which the tail drives must rapidly respond to the regenerative condition and control conveyor over speed. The Head drives were therefore configured to operate under a PLC based torque load sharing control scheme with the tail drives (Method 3). There are several schemes for PLC based torque load sharing control which is dependent upon the functionality required by the conveyor mechanical design. Since the original mechanical design of the conveyor was not being

changed, CDI proposed to use an equal load sharing scheme with dead band control to prevent instability and oscillations between the head and tail drives.

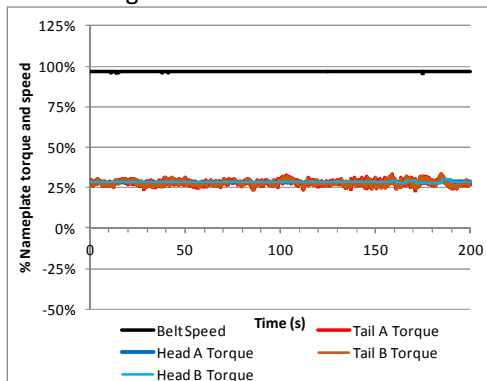
Following the onsite modifications and re-commissioning of the drive configuration and conveyor control system the PLC trend data was analyzed to verify the drive torque load sharing issues have been resolved. Conveyor CV-002B now operates with all drives equally sharing the conveyor load with the Tail drives torque fluctuating in response to the speed reference operation and the head drives gently modulating under the PLC based dead band load sharing torque control (Figure 14)

Figure 14 - CV-002B Running motor torques – After control changes. All drives operating at similar torque levels with head drives operating in PLC based dead band load sharing with tail drives.
